TRAGEDY AT COOLANGATTA

Sixty years on, *Flight Safety* writer, Macarthur Job, looks at how a loading problem led to one of Australia's worst civil aviation accidents.

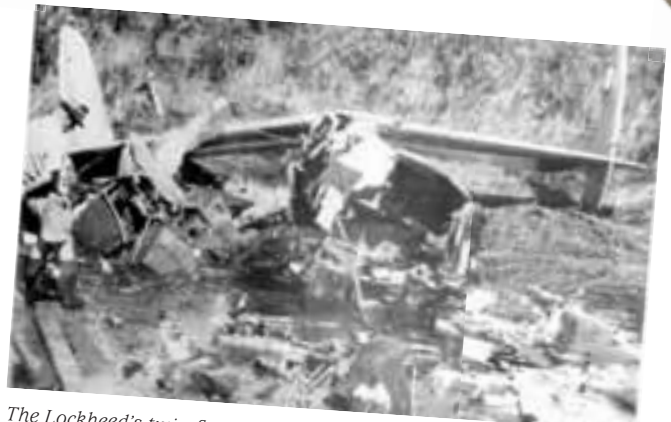
Accident investigators arrived next morning from the Department of Civil Aviation. They found the Lockheed had struck the ground only about 100 metres beyond the eastern end of the strip. The machine had crashed at a high rate of descent, but at very low forward speed. Apart from extensive destruction by fire, there was vertical compression of the fuselage, and severe downward bending of the wings, engine mountings and tailplane.

The Lockheed's twin-finned tail assembly survived the fire, but shows downward distortion from the high vertical impact.

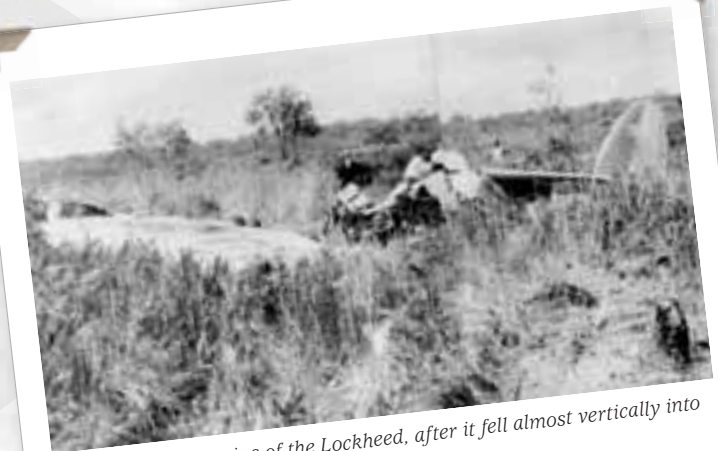
The burnt-out remains of the Lockheed, after it fell almost vertically into swampy ground.
